PHOTOGRAPHIC SURVEY OF THE LDEF MISSION

NASA Special Publication 531

Robert L. O'Neal

Langley Research Center
Hampton, Virginia 23681-0001

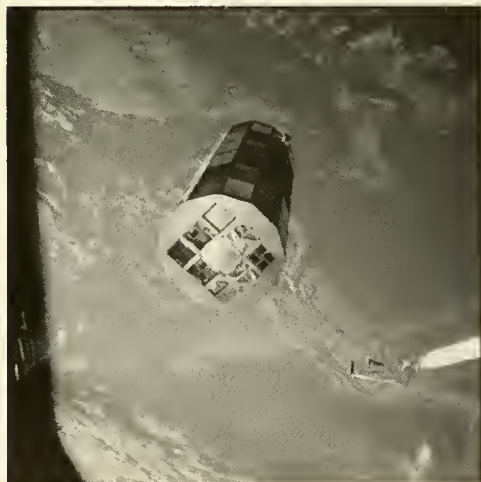
Figure 22
Photo No.: S32-85-008
Dup. Neg. No.: L90-10468
LISAR No.: EL-1994-00102
Photo Credit: JSC
Photo Date: 1/12/90
Location: In Flight
Subject: Capture of LDEF

Figure 22 (In Flight). This figure shows the space end of the LDEF as *Columbia* descended with the RMS poised to complete the capture maneuver. The Earth and clouds are in the background. Note the extensive damage to the thermal covers of experiment M0001. The aft flight deck window frame obscures an area along the left side of the photograph.

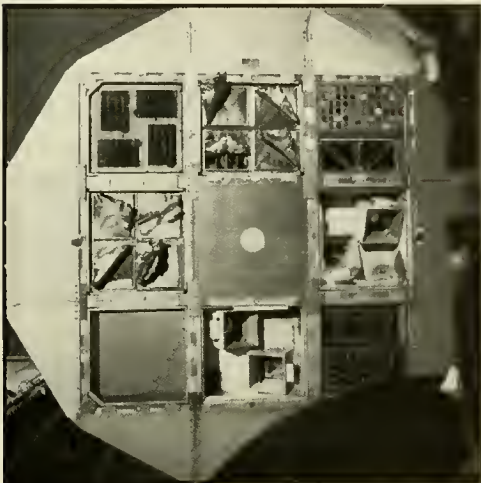
Figure 24 (In Flight). This view shows the space end of the LDEF during berthing in the cargo bay of the orbiter with the RMS. Note the damage to the thermal covers of the experiment M0001 and the prominent brown discolorations on other experiment hardware.

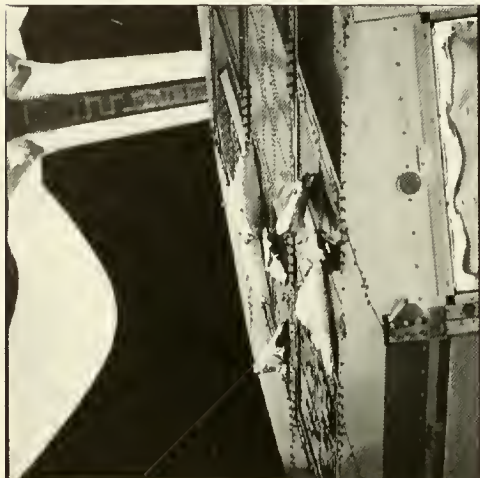
Figure 25 (In Flight). This oblique view is of the LDEF on the RMS with the space end in the foreground. Note the damaged thermal covers of experiment M0001. The orbiter vertical stabilizer and one of the orbiter maneuvering system (OMS) pods are in the left of the photograph.

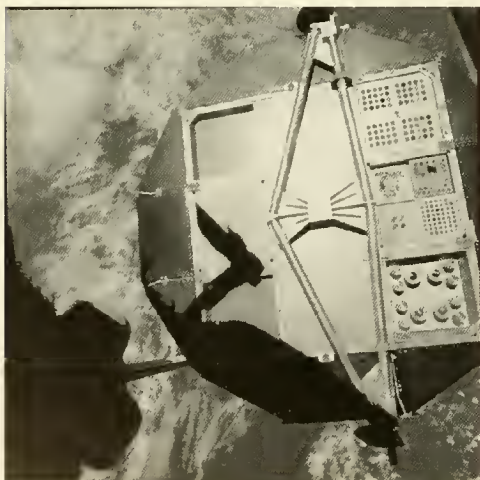
Figure 26 (In Flight). This view shows the Earth-facing end of the LDEF on the RMS with the cloud cover of the Earth as background. Note the brown discolorations on several of the painted surfaces of the experiments. The orbiter, in the lower left corner of the photograph, is in the shadow of the LDEF. There is a shadow of the RMS across the left portion of the photograph.

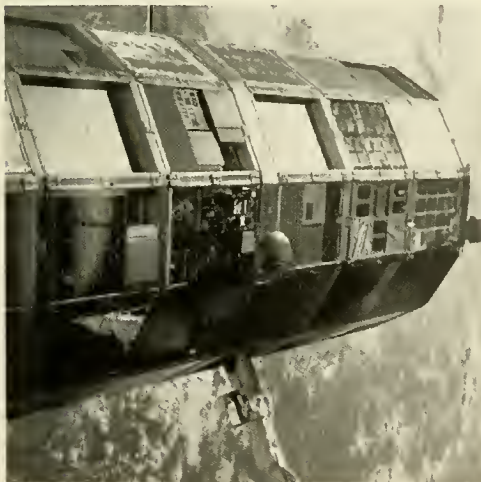
Figure 28 (In Flight). This close-up side view shows bays A through E in rows 2 through 5 with the LDEF on the RMS. Direct sun and reflections caused some experiment details in row 4 to be washed out, while low light levels caused a lack of detail in other rows. Wrinkles in the thermal screens in tray B3 are prominent. The thermal covers of trays of experiment AO178 in row 5 show reflections of the Earth and the sky.

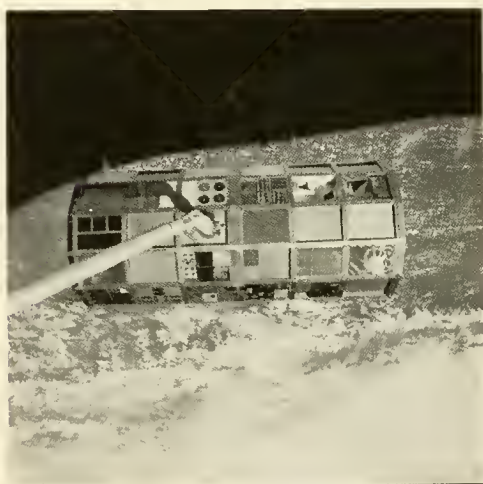
Figure 34 (In Flight). This wide-angle view shows bays A through F in rows 11, 12, and 1 through 3 with the LDEF on the RMS against a background of the Earth and clouds. The aft flight deck window frame obscures the upper part of the photograph. Note the clean appearance of the white paint in row 12 compared with similar paint on experiment hardware in rows 2 and 3. The original bright yellow paint on the trunnion scuff plates on row 3 has darkened significantly.

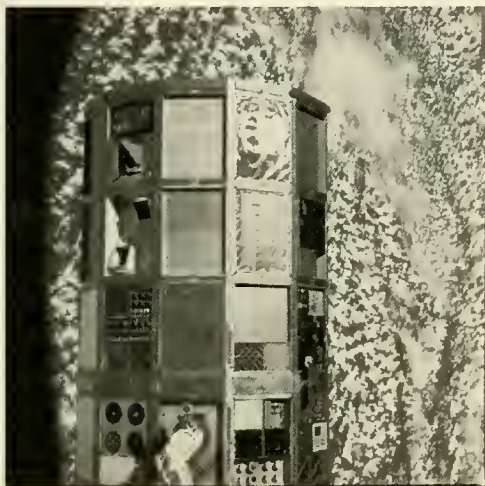
Figure 35 (In Flight). This side view shows bays C through F in rows 11, 12, and 1 through 3 with the LDEF on the RMS. The aft flight deck window frame forms a shadow on the left edge of the photograph. The Earth with a cloud cover provides the background. Note the clean appearance of the white paint on the thermal covers in row 12 when compared with similar paint on the hardware in rows 2 and 3. The white paint dots on the experiment tray clamp blocks on row 12 appear clean; however, the dots darken progressively as row 3 is approached. The original bright yellow paint on the trunnion scuff plates on row 3 has darkened significantly.

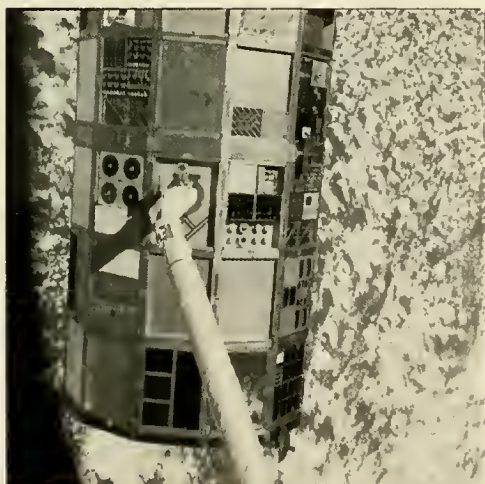
Figure 36 (In Flight). This side view shows bays A through D in rows 11, 12, and 1 through 3 with the LDEF on the RMS. The aft flight deck window frame forms a shadow on the left edge of the photograph and the Earth with a cloud cover provides the background. Note the clean appearance of the white paint on the thermal covers in row 12 when compared with similar paint on experiment hardware in rows 2 and 3. The original bright yellow paint on the trunnion scuff plates on row 3 has darkened significantly.

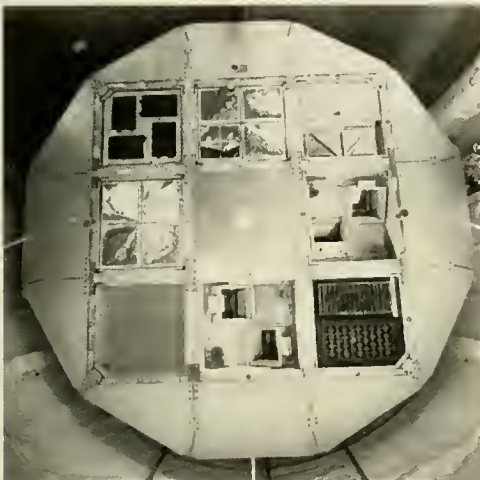
Figure 43 (Postflight). This view of the space end of the LDEF was taken from the cargo bay access hatch after the *Columbia* landed at Edwards Air Force Base, California. The cargo bay liner is visible in the bottom of the photograph. The radiators, which are located on the inside of the orbiter payload bay doors, are visible in the top. The three yellow balls on the aluminum support rods (whiskers) that are fixed in the cargo bay were used for berthing the LDEF during retrieval operations. A brown discoloration appears to be spread over the surface of the space end of the LDEF. This discoloration appears to be lighter on the anodized aluminum thermal panel surfaces and darker on the experiment surfaces that were coated with the Chemglaze A276 white thermal control paint. The discoloration on the uncoated aluminum hardware (such as the end frame splice plates) is also darker. The amber and red reflectors seem to have little apparent degradation.

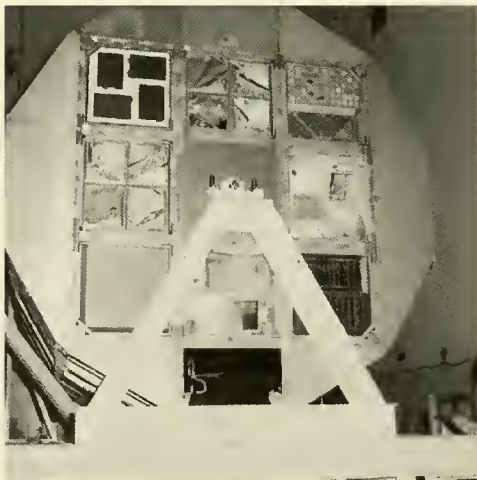
Figure 46 (Postflight). This postflight view is of the space end of the LDEF in the SAEF II. The discoloration in the areas of trays H6 and H9 (containing experiment AO038) and the damage to the thermal covers of experiment M0001 in trays H3 and H12 are evident. Note that the thermal panel below tray H6 has been removed.

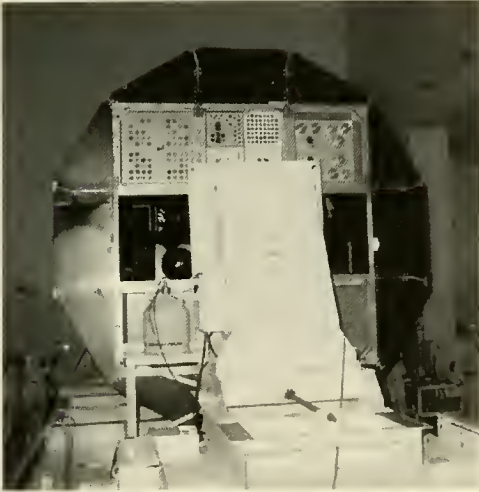
Figure 47 (Postflight). This postflight view is of the Earth end of the LDEF in the SAEF II. Some discoloration of the thermal panels on the left side of the photograph is visible. This area was affected by the end support beam in flight, which was removed when this photograph was made. The canister on the stand adjacent to tray G8 was part of the instrumentation setup for radiation measurements.

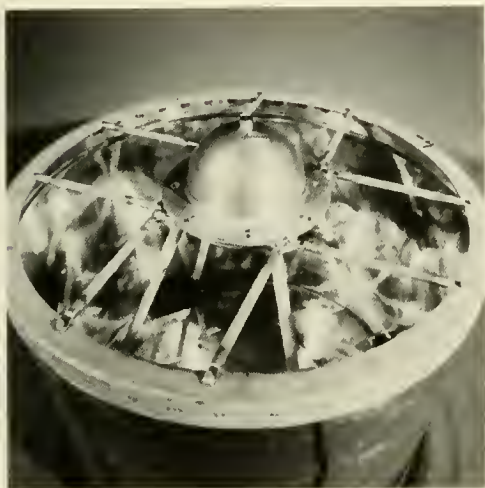
Figure 63 (Postflight). This photograph is of the magnetically anchored viscous damper after removal from the LDEF. The bolts that fastened the damper to the fiberglass support structure have been removed. The damper had a gold coating for thermal control in flight.

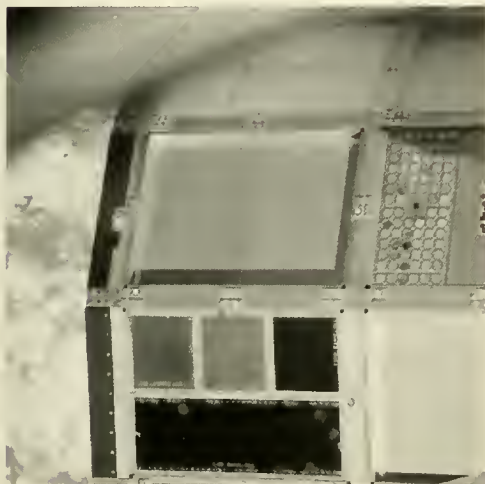
Figure 65 (In Flight). The test panel discoloration pattern visible in the prelaunch photograph remained unchanged. The identification numbers on all panels changed to a light brown. The ripple patterns on the polyimide panels were the result of manufacturing techniques and were not caused by exposure to space.

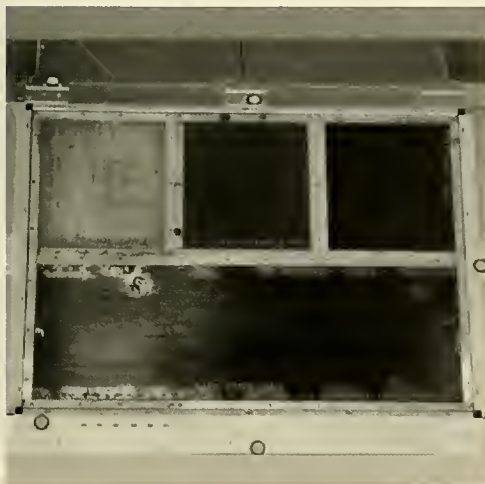
Figure 66
Photo No.: KSC-390C-609.02
Dup. Neg. No.: L92-17828
LISAR No.: EL-1994-00119
Photo Credit: KSC
Photo Date: 1/30/90
Location: KSC OPF
Subject: Postflight Survey of Panels in Tray A1

Figure 66 (Postflight). This photograph shows considerably more detail than the in-flight photograph. The horizontal lines on the honeycomb panel that appear to be cracks from space exposure are fine lines of excess epoxy resin that were formed during the manufacturing bagging and curing process. The harsh white of the epoxy adhesive along the rivet lines is from the lighting conditions in the OPF. The greater detail shows that a stain exists at most composite and mounting strip interfaces.

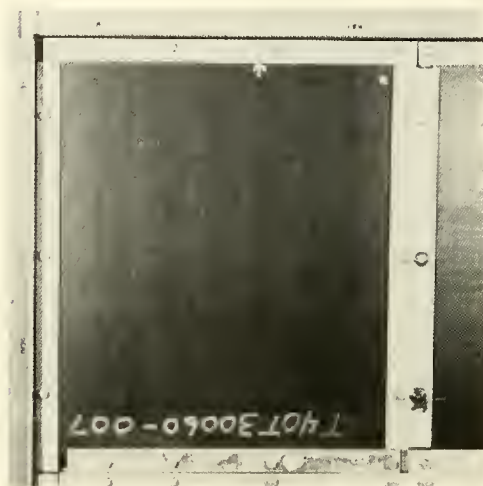
Figure 67 (Postflight). This close-up photograph of the upper left one-sixth of the tray shows the ripple pattern in the polyimide panel. The brown discolorations on the aluminum retaining strips are prominent.

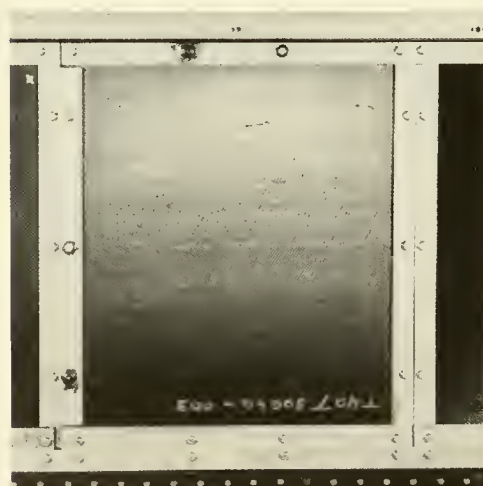
Figure 68 (Postflight). This close-up photograph of the upper center one-sixth of the tray shows the ripple and the texture pattern of the polyimide test panel. The discoloration at the retaining strip and the test panel interface is visible.

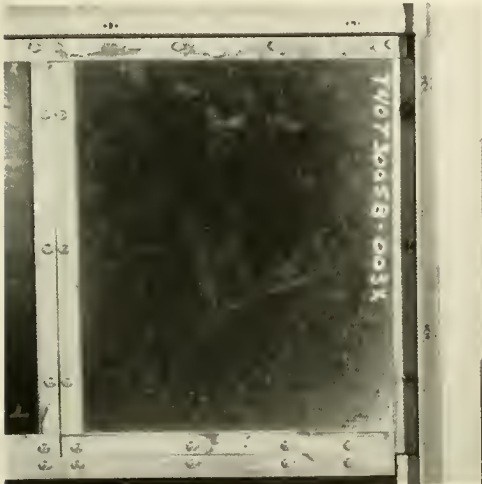
Figure 69 (Postflight). This close-up photograph of the upper right one-sixth of the tray shows the honeycomb pattern in the graphite-epoxy test panel. Light reflections caused the right side, especially the lower section, of the panel to be somewhat lighter than the rest of the panel. Discoloration spots on the aluminum retaining strips are visible.

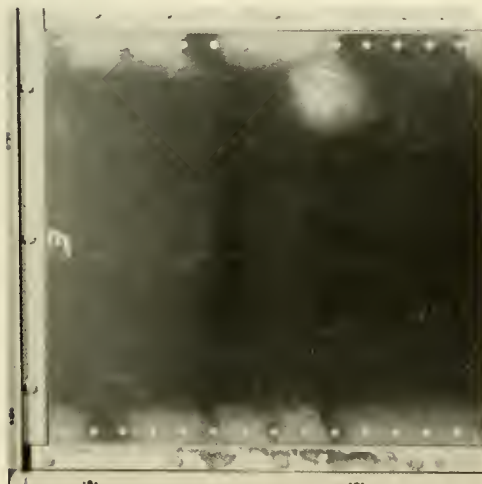
Figure 70 (Postflight). This close-up photograph of the lower left one-sixth of the tray shows a portion of the graphite-epoxy test panel. The lighter spots around the upper and lower edges are the result of repairs that were made to the test panels after manufacture and are not due to any effects of the space exposure. The honeycomb pattern of the panel structure is visible.

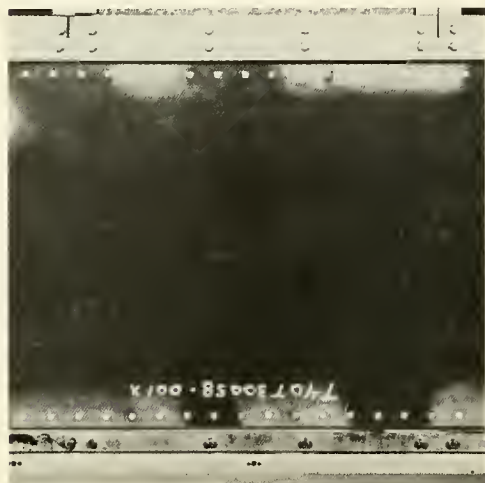
Figure 71 (Postflight). This close-up photograph of the lower center one-sixth of the tray shows the center portion of the graphite-epoxy test panel. The light spots around the upper and the lower edges are the result of repairs that were made to the test panels after manufacture and are not due to any effects of space exposure. The honeycomb pattern of the panel structure is particularly visible in these spots.

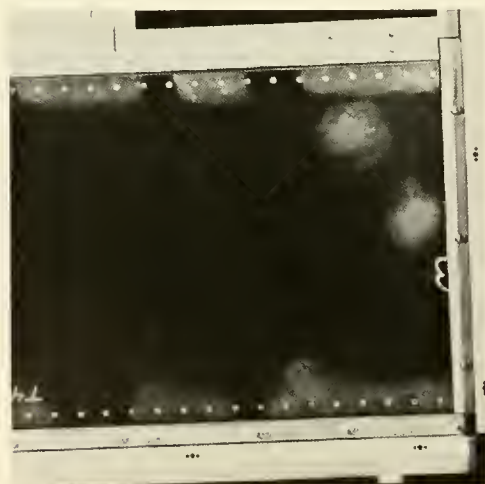
Figure 72 (Postflight). This close-up photograph of the lower right one-sixth of the tray shows the right portion of the graphite-epoxy test panel. The light spots around the edges are the result of repairs that were made to the test panels after manufacture and are not due to space exposure. The honeycomb pattern of the panel structure is particularly visible around these spots.

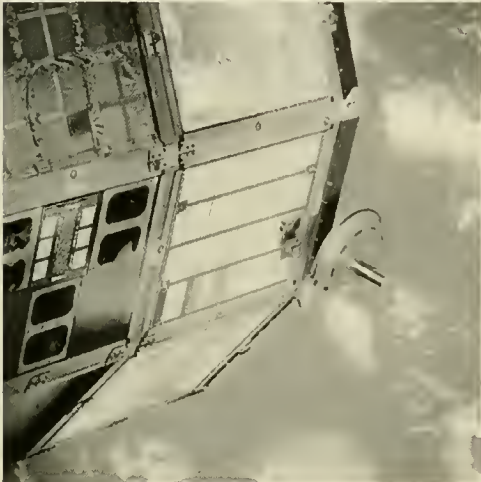
Figure 73 (In Flight). In this photograph, tray A2 is located in the lower row. The thermal cover is without visible damage; however, it is more taut than in the prelaunch photograph. The wrinkled spots on the thermal cover are over areas where Velcro pads are bonded to the back of the cover. The rippled effect around the cover edges occurs between the attachment pads.

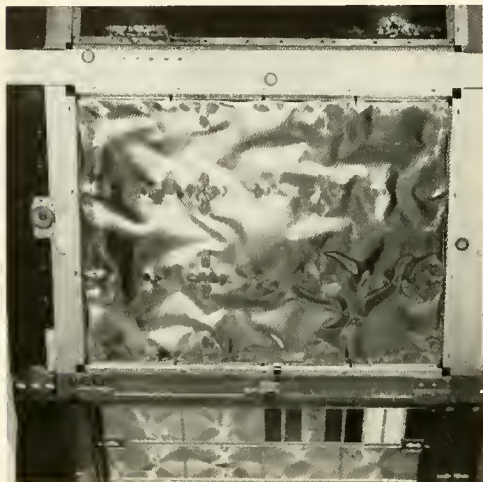
Figure 74 (Postflight). The thermal cover appears to be specular and undamaged. It is less taut than in the in-flight photograph. The uniformly located oval spots on the thermal cover are areas where Velcro pads attach the thermal cover to the support frame; these spots are more visible than in the prelaunch photograph. The scallop effect around the cover edges occurs between the attachment pads and shows the upper edge of the support frame. The ground strap appears to be in place with no visible damage, although it is darker.

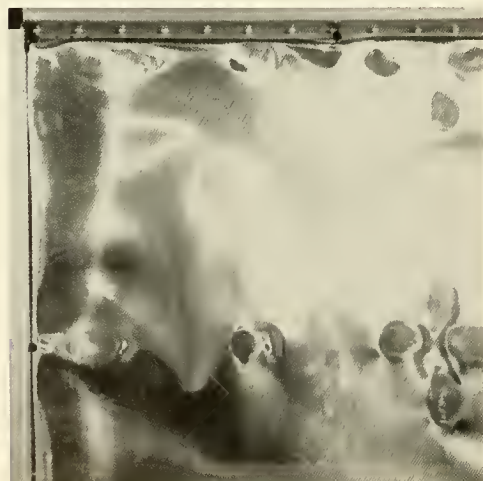
Figure 75 (Postflight). This close-up photograph of the upper left one-sixth of the tray shows a faint pattern of marks similar to brush marks in a top-to-bottom direction. This pattern is somewhat less specular than other regions. Observation of this tray during operations in the OPF and later in the SAEF II showed less specular areas on the thermal cover. Some fingerprints on the thermal cover are visible. The reflective properties of the uneven surface of the cover result in various light and color patterns.

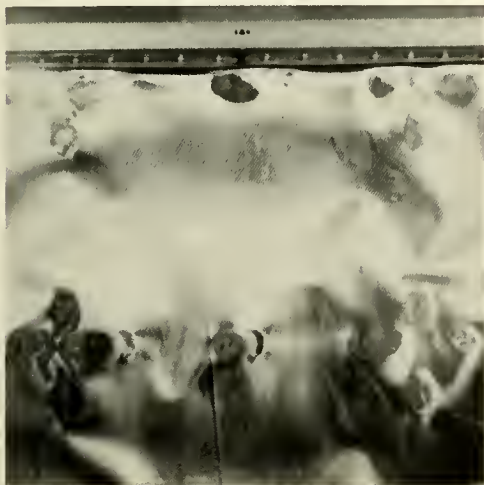
Figure 76 (Postflight). This close-up photograph of the upper center one-sixth of tray A2 shows an obvious pattern of marks similar to brush marks in a top-to-bottom direction. The pattern is less specular than in other areas. This appearance was present in observations in OPF and SAEF II operations. The reflective properties of the uneven surface of the cover result in various light and color patterns.

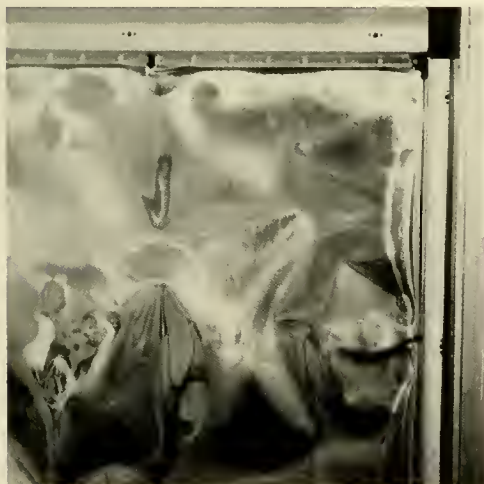
Figure 77 (Postflight). This close-up photograph of the upper right one-sixth of tray A2 shows a faint pattern of marks similar to brush marks in a top-to-bottom direction. These marks are not as prominent as in the left portions of the tray. The reflective properties of the uneven surface of the cover result in various light and color patterns.

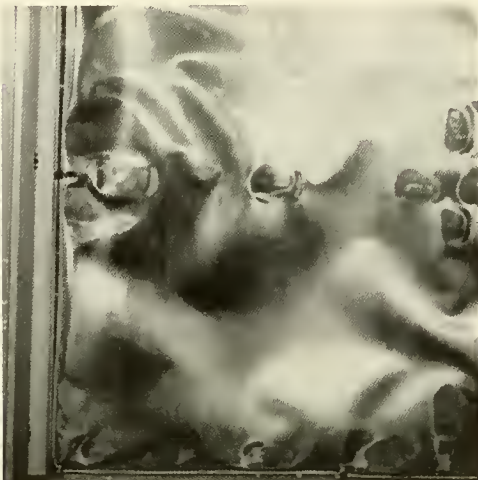
Figure 78 (Postflight). This close-up photograph of the lower left one-sixth of tray A2 shows a pattern of marks similar to brush marks in a top-to-bottom direction. The light area in the upper right is a reflection of photographic lights. The reflective properties of the uneven surface of the cover result in various light and color patterns.

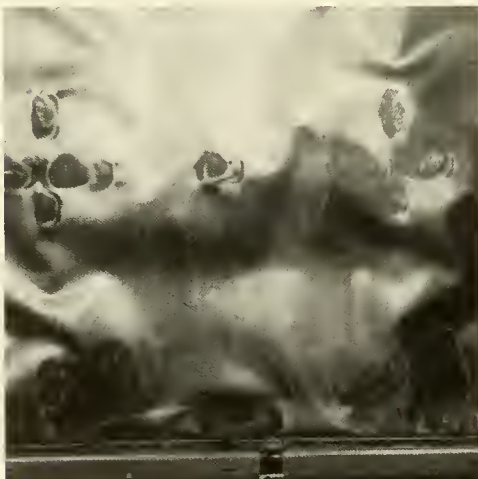
Figure 79 (Postflight). This close-up photograph of the lower center one-sixth of tray A2 has a bright area in the upper part of the frame that is caused by light reflections. The lower portions are somewhat darker because of lighting. The reflective properties of the uneven surface of the cover result in various light and color patterns.

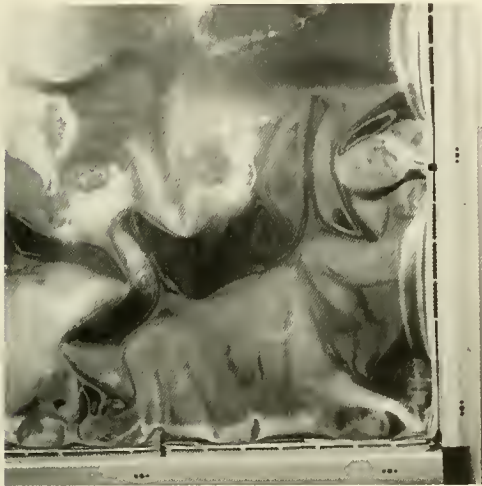
Figure 80 (Postflight). This close-up photograph of the lower right one-sixth of tray A2 is somewhat dark because of lighting. The reflective properties of the uneven surface of the cover result in various light and color patterns.

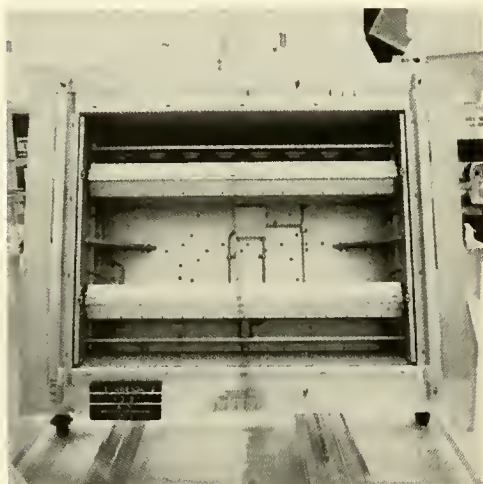
Figure 81 (Preflight). This prelaunch photograph shows two clamshell canisters in closed positions. The canisters house collector surfaces made of 99.99-percent-pure gold sheets that are 0.5-mm thick. Other smaller samples of Al (99.999-percent pure), Ti (99.9-percent pure), Be (99.9-percent pure), Zr (99.8-percent pure), C (99.999-percent pure), Kapton film (a polyimide), and Teflon filters were also exposed.

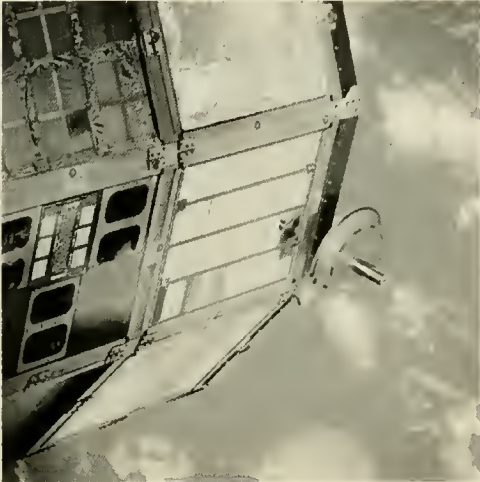
Figure 82 (In Flight). The canisters are shown in open positions in the center tray of bay A. They were expected to open about 2 weeks after launch and close about 11 months into the mission. All exposed materials are secure and no damage is evident. Contamination stain coats the tray flanges and the aluminum canister hardware. The end support beam scuff plate in the photograph was a bright yellow prior to launch, but it is now a much darker mustard yellow after space exposure.

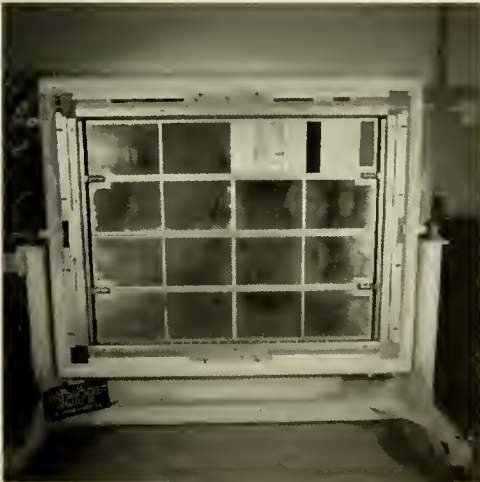
Figure 83 (Postflight). The experiment is shown in the postflight configuration before the canisters were closed with ground support equipment that bypassed the onboard electronic circuits. There is no visible damage. The reflection of a video camera on a tripod and light sources are visible in the surfaces of the gold foil.

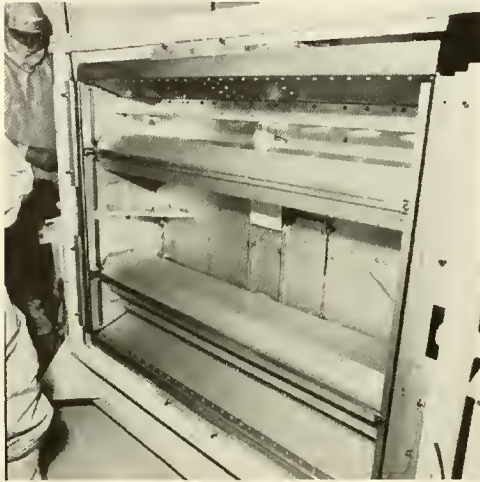
Figure 84 (Postflight). The experiment canisters are shown after being closed by ground support equipment. The experiment hardware has no damage.

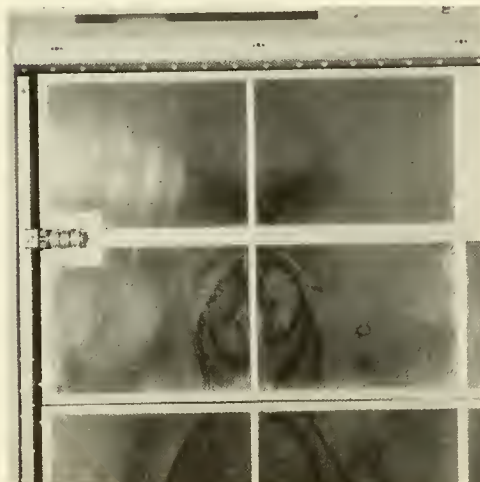
Figure 85 (Postflight). This photograph of the upper left one-fourth of the tray shows light and room reflections in the gold foil. The foil appears to be in preflight condition.

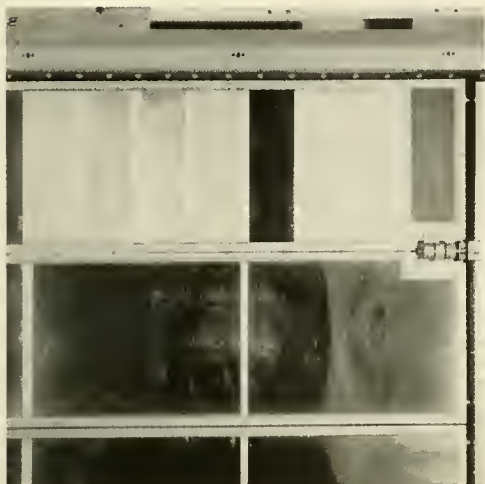
Figure 86 (Postflight). This photograph of the upper right one-fourth of the tray shows light and room reflections in the highly reflective gold foil. The foil appears to be in preflight condition. Photographic lights washed-out details of the test strips along the top of the tray.

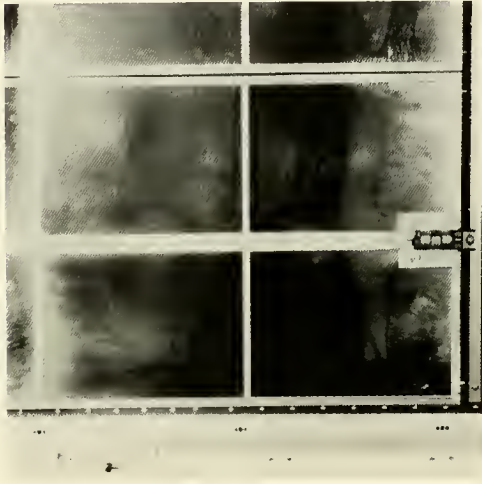
Figure 88 (Postflight). This photograph of the lower right one-fourth of the tray shows light and room reflections in the highly reflective gold foil. The green is a reflection of the clean room garments that were worn by nearby personnel. The foil appears to be in preflight condition.

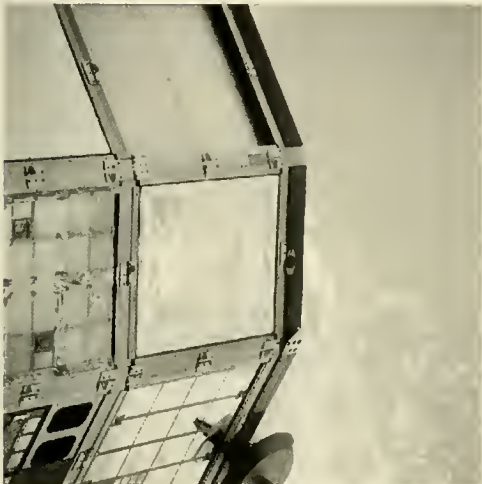
Figure 89 (In Flight). The thermal cover appears to be specular and undamaged, but it is more taut than in the prelaunch photograph. The wrinkled spots on the thermal cover are areas where Velcro pads are bonded to the back of the cover. The scalloped effect around the cover edges occurs between the attachment pads. The ground strap appears to be in place and to have no visible damage.

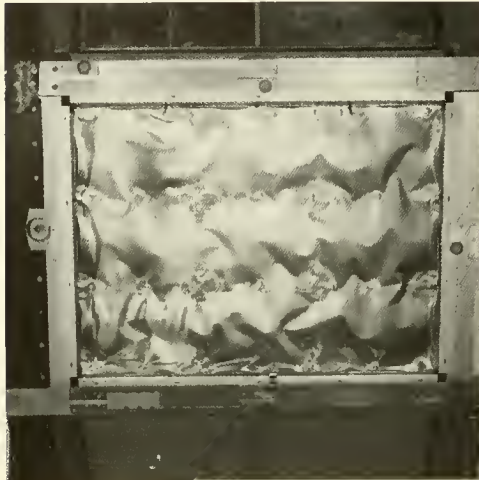
Figure 90 (Postflight). The thermal cover appears to be specular and undamaged. It appears less taut than in the in-flight photograph. The uniformly located oval spots on the thermal cover are areas where Velcro pads attached the thermal cover to the support frame. These attachment pads are more visible than in the prelaunch photograph. The scallop effect around the cover edges occurs between the attachment pads and shows the upper edge of the support frame. The ground strap appears to be in place with no visible damage.

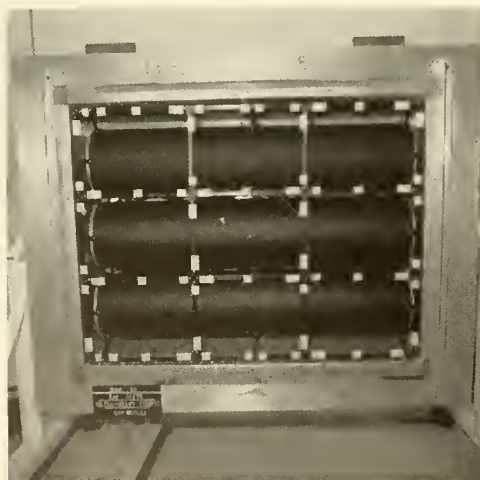
Figure 91 (Postflight). This postflight photograph was taken in SAEF II after the silvered Teflon thermal cover had been removed. All experiment hardware appears to be in prelaunch condition and to be securely in place. The three cylindrical pressure vessels that contain the experiment detectors are shown mounted in the experiment tray. The frame for mounting the thermal cover is in the foreground. The white rectangles on the frame are Velcro pads bonded to the frame for attaching the thermal cover. The Velcro pads are in excellent condition. The top half of the cylinders and the thermal cover frame were painted black to meet thermal control requirements.

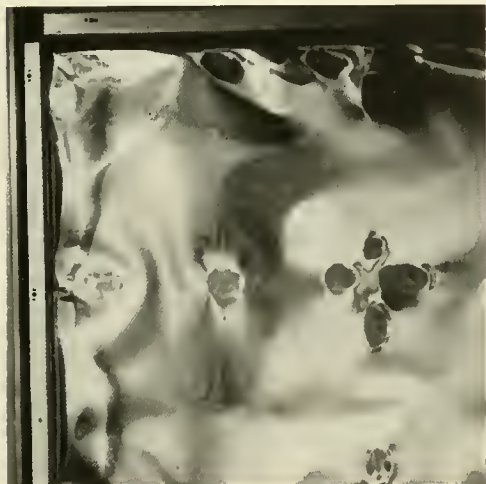
Figure 92 (Postflight). This photograph is of the upper left one-sixth of the tray. The thermal cover appears specular and undamaged. The reflective properties of the uneven surface of the cover result in various light and color patterns. The locations of the Velcro attachment pads are obvious.

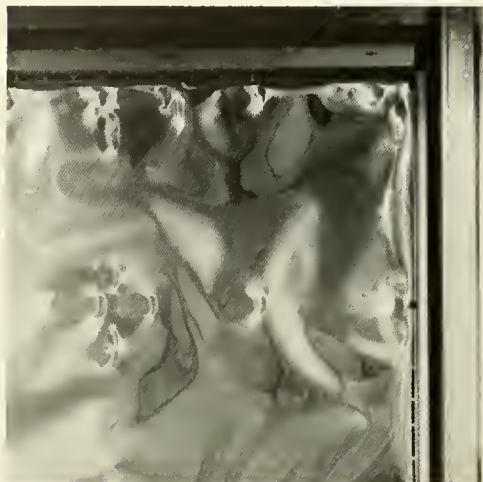
Figure 94
Photo No.: KSC-390C-1743.09
Dup. Neg. No.: L91-7613
LISAR No.: EL-1994-00243
Photo Credit: KSC
Photo Date: 3/8/90
Location: KSC SAEF II
Subject: Postflight Detail of Upper Right of Tray A4

Figure 94 (Postflight). This photograph is of the upper right one-sixth of the tray. The thermal cover appears specular and undamaged. The reflective properties of the uneven surface of the cover result in various light and color patterns. The locations of the Velcro attachment pads are obvious.

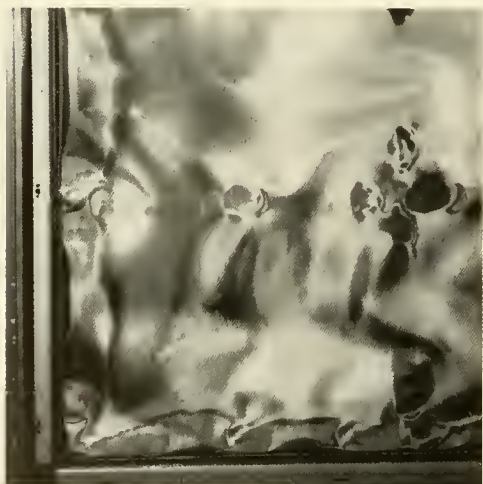
Figure 95
Photo No.: KSC-390C-1743.10
Dup. Neg. No.: L91-7614
LISAR No.: EL-1994-00244
Photo Credit: KSC
Photo Date: 3/8/90
Location: KSC SAEF II
Subject: Postflight Detail of Lower Left of Tray A4

Figure 95 (Postflight). This photograph is of the lower left one-sixth of the tray. The thermal cover appears specular and undamaged. The reflective properties of the uneven surface of the cover result in various light and color patterns. The locations of the Velcro attachment pads are obvious.

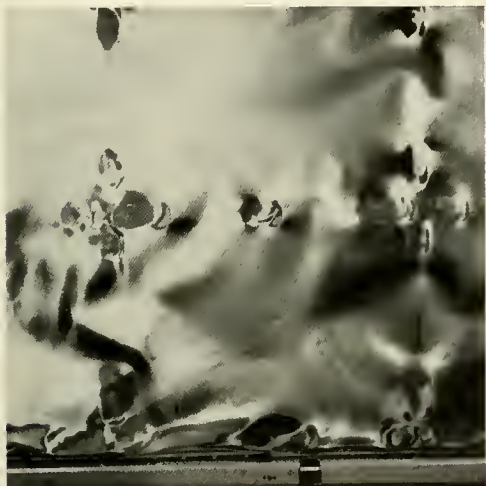
Figure 96
Photo No.: KSC-390C-1743.11
Dup. Neg. No.: L91-7615
LISAR No.: EL-1994-00245
Photo Credit: KSC
Photo Date: 3/8/90
Location: KSC SAEF II
Subject: Postflight Detail of Lower Center of
Tray A4

Figure 96 (Postflight). This photograph is of the lower center one-sixth of the tray. The thermal cover appears specular and undamaged. The reflective properties of the uneven surface of the cover result in various light and color patterns. The locations of the Velcro attachment pads are obvious.

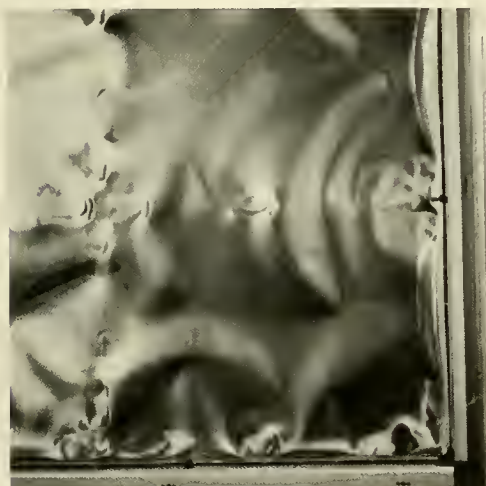
Figure 97
Photo No.: KSC-390C-1743.12
Dup. Neg. No.: L91-7616
LISAR No.: EL-1994-00246
Photo Credit: KSC
Photo Date: 3/8/90
Location: KSC SAEF II
Subject: Postflight Detail of Lower Right of
Tray A4

Figure 97 (Postflight). This photograph is of the lower right one-sixth of the tray. The thermal cover appears specular and undamaged. The reflective properties of the uneven surface of the cover result in various light and color patterns. The locations of the Velcro attachment pads are obvious.

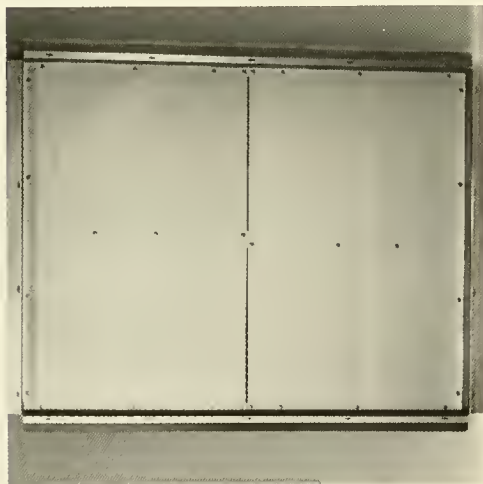
Figure 98 (Preflight). Because trays dedicated to experiment S0001 (except tray A6, which had the target for the keel camera) were not photographed prior to flight, a spare tray was photographed for descriptive purposes. Experiment S0001 consisted of two 3/16-in-thick chromic-anodized aluminum panels that were mounted in a 3-in-deep peripheral tray. The panel had two coatings: a thin layer of chromic anodization that faced the exterior and a Chemglaze-306 black paint that faced the interior. Both coatings contributed significantly to thermal control of the LDEF. The pink and greenish-gray tints and the vertical stripes on the two debris panels were by-products of the chromic anodization coating process. The anodization appears to make surface features or markings more visible.

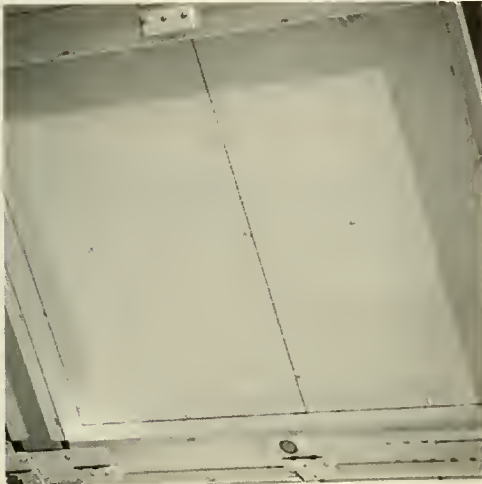
Figure 99
Photo No.: S32-76-079
Dup. Neg. No.: L90-10395
LISAR No.: EL-1994-00059
Photo Credit: JSC
Photo Date: 1/12/90
Location: In Flight
Subject: In-Flight Survey of Tray A5

Figure 99 (In Flight). Fingerprints that were observed on the lower tray flange and the sidewall indicate the lack of proper preflight handling and cleaning. The greenish-gray and pink tints on the two debris panels are by-products of the chromic anodization coating process and are not attributed to contamination or exposure to the space environment.

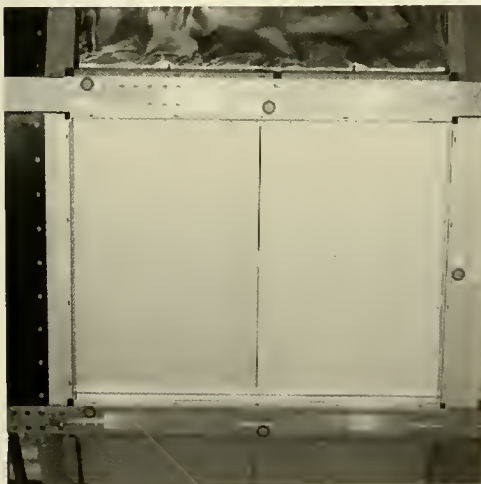
Figure 100
Photo No.: KSC-390C-1035.09
Dup. Neg.: L90-13454
LISAR No.: EL-1994-00185
Photo Credit: KSC
Photo Date: 2/9/90
Location: KSC SAEF II
Subject: Postflight Survey of Tray A5

Figure 100 (Postflight). The greenish-gray and pink tints on the two debris panels are by-products of the chromic anodization coating process and are not attributed to contamination or exposure to the space environment. The fingerprints along the edges of the left panel that were observed in the in-flight photograph are still visible. Those visible previously along the top edges have been washed out by the lighting. The light band along the sides and across the bottom of the panels is caused by light reflecting from the tray sidewalls.

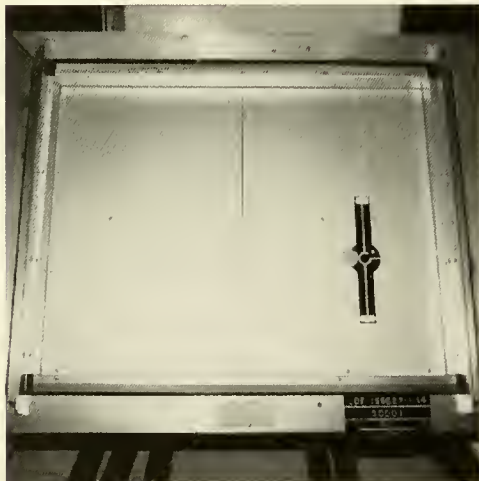
Figure 101 (Preflight). This tray is typical of the other 18 trays dedicated to experiment S0001 except for the target for the Shuttle keel camera and the reflector. The target and the reflector were visual aids for berthing the LDEF during retrieval. This photograph of tray A6 and the photograph of the spare flight tray shown in figure 98 can be used to judge the preflight appearance of the witness plates for experiment S0001. The greenish-gray and pink tints are by-products of the chromic anodization coating process. The line pattern is due to the rolling mill operation during manufacturing. The anodization makes such surface features more visible.

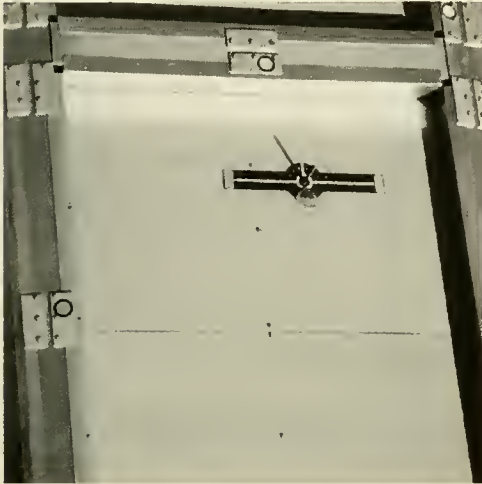
Figure 102
Photo No.: S32-76-087
Dup. Neg. No.: L90-10396
LISAR No.: EL-1994-00060
Photo Credit: JSC
Photo Date: 1/12/90
Location: In Flight
Subject: In-Flight Survey of Tray A6

Figure 102 (In Flight). The pink and greenish-gray tints and the horizontal stripes on the two debris panels are by-products of the chromic anodization coating process and are not attributed to exposure to the space environment. The blue is due to lighting and is not a true change in surface color. The brown irregular discolorations along the center edges of the debris panels appear to be fingerprints from prelaunch handling. The black unit located on the top panel is a target for the keel camera that was used during the berthing of the LDEF. The stripes and the tip of the vertical rod of the target for the keel camera appear darker than in the prelaunch photograph. The light band across the top panel is reflected light from the tray sidewall and the dark band down the right side of the panels is a shadow from the tray sidewall.

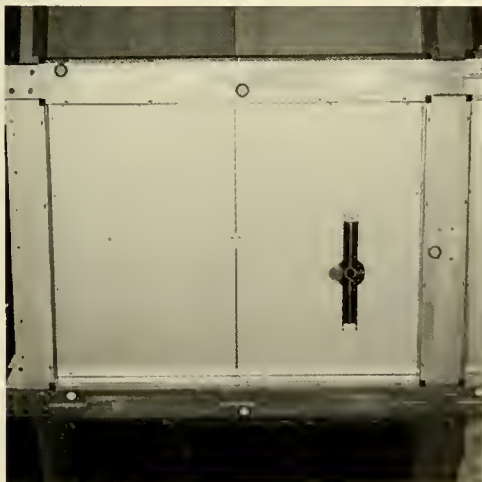
Figure 103
Photo No.: KSC-390C-1035.03
Dup. Neg. No.: L90-13448
LISAR No.: EL-1994-00181
Photo Credit: KSC
Photo Date: 2/9/90
Location: KSC SAEF II
Subject: Postflight Survey of Tray A6

Figure 103 (Postflight). The pink and the greenish-gray tints on the two debris panels are by-products of the chromic anodization coating process and are not attributed to contamination or exposure to the space environment. The fingerprints along the center edges of the debris panels that were observed in the in-flight photograph are still visible. The vertical streaks on the debris panels appear to be the same as on the prelaunch photograph. The stripes and the tip of the vertical rod of the target for the keel camera appear darker than in the prelaunch photograph. The light band along the right side and across the bottom of the panels is caused by light reflecting from the tray sidewalls.

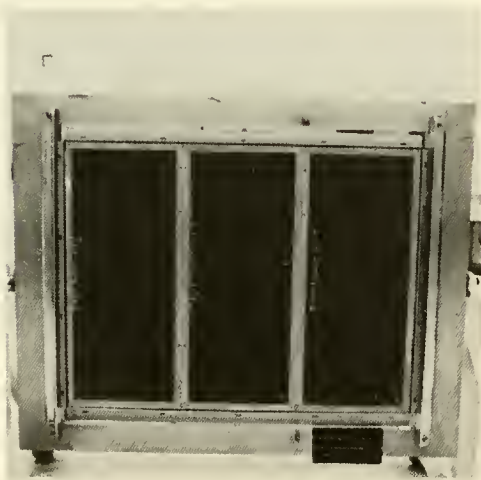
Figure 104 (Preflight). The experiment in this tray consisted of three graphite-polyimide laminate panels and associated mounting hardware. Each panel occupied one-third of the LDEF tray: a PMR-15 precured graphite-polyimide panel (T40T30060-009) was in the right one-third section, an F-178/T300 cocured graphite-polyimide panel (T40T30060-005) was in the center one-third section, and an F-178/T300 precured graphite-polyimide panel (T40T30060-001) was in the left one-third section of the tray. Each panel was identified with yellow markings. The dull gold-colored coating has been scraped from the aluminum mounting strip near the upper left tray corner. The PMR-15 panel is a uniform dark brown. The panel has several off-white marks in the lower right corner. Light grayish-brown discolorations are visible behind the identification number and behind the off-white marks. The F178/T300 cocured panel is dark brown. The F178/300 precured panel is dark brown and appears to have a lighter brown area along the vertical center, which extends from the bottom to the top of the panel.

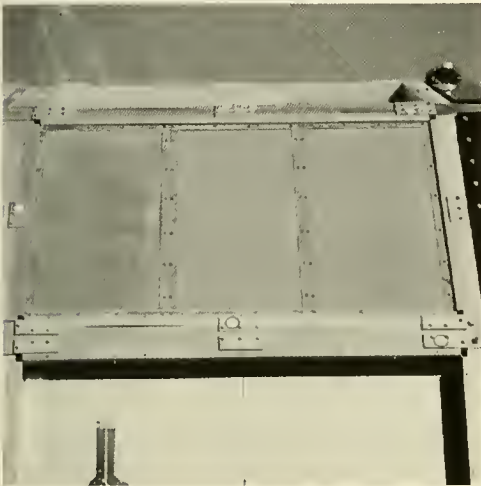
Figure 105
Photo No.: S32-76-095
Dup. Neg. No.: L90-10398
LISAR No.: EL-1994-00061
Photo Credit: JSC
Photo Date: 1/12/90
Location: In Flight
Subject: In-Flight Survey of Tray A7

Figure 105 (In Flight). In this photograph, the dull gold-colored coating that was observed on the aluminum mounting strips in the preflight photograph has turned to a medium brown. The yellow numbers seem darker than in prelaunch conditions, but the white markings appear the same. There seems to be fine horizontal lines, cracks, and crazing on the surface of each panel. The PMR-15 panel on the left appears to have changed from brown (at prelaunch) to light gray. A geometric pattern, probably from the laminating process, is visible on the surface. Scratch marks and abrasions on the lower left edge of panel were on the preflight photographs. The F-178/T300 cocured panel in the center seems to have changed from dark brown to light gray. The F-178/T300 precured panel on the right appears to have changed from dark brown with a lighter brown area along the vertical center to a uniform light gray.

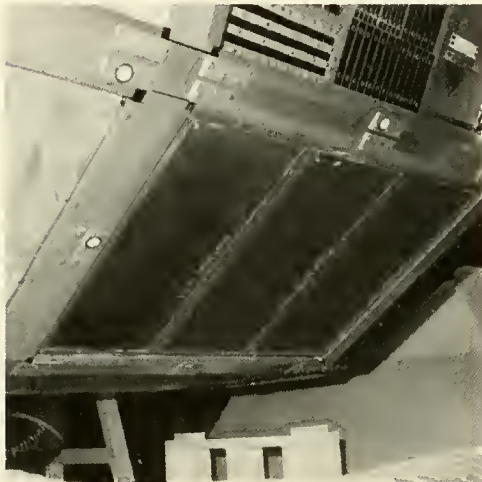
Figure 106
Photo No.: KSC-390C-725.04
Dup. Neg. No.: L92-17551
LISAR No.: EL-1994-00163
Photo Credit: KSC
Photo Date: 2/1/90
Location: KSC O & C building
Subject: Postflight Survey of Tray A7

Figure 106 (Postflight). The areas on the aluminum mounting strips where the coating has been scraped or abraded can be seen in greater detail under the better lighting in this photograph. The coating color remains essentially the same. The yellow numbers seem to be a little lighter than in the in-flight photograph, but the white markings appear unchanged. The fine horizontal lines, cracks, and crazing are still visible on the surface of the panels. The PMR-15 panel on the left seems to have a gray haze over the gray brown surface. The scratch marks and abrasions on the lower left edge of the panel were on the preflight photographs. The geometric pattern visible in the in-flight photograph is not visible in this photograph. The F-178/T300 cocured panel in the center appears to have changed from the light gray in the in-flight photograph to a brownish gray. The F-178/T300 precured panel on the right seems to have changed to a brownish gray from the light gray visible in the in-flight photograph.

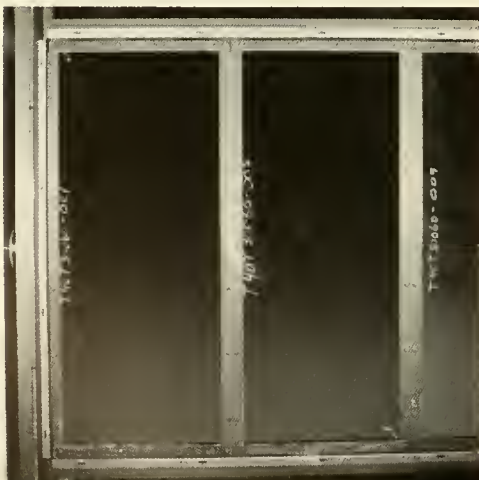
Figure 107
Photo No.: KSC-390C-2145.10
Dup. Neg. No.: L91-7659
LISAR No.: EL-1994-00503
Photo Credit: KSC
Photo Date: 3/21/90
Location: KSC SAEF II
Subject: Postflight Detail of Tray A7

Figure 107 (Postflight). This close-up photograph is of the two left panels (F-178/T300 precured and F-178/T300 cocured). The yellow numbers appear lighter than in the in-flight photograph. The fine horizontal lines, cracks, and crazing are still visible on the panel surface. The F-178/T300 precured panel seems to have changed to a brownish gray from the light gray visible in the in-flight photograph. The F-178/T300 cocured panel appears to have changed from the light gray in the in-flight photograph to a brownish gray.

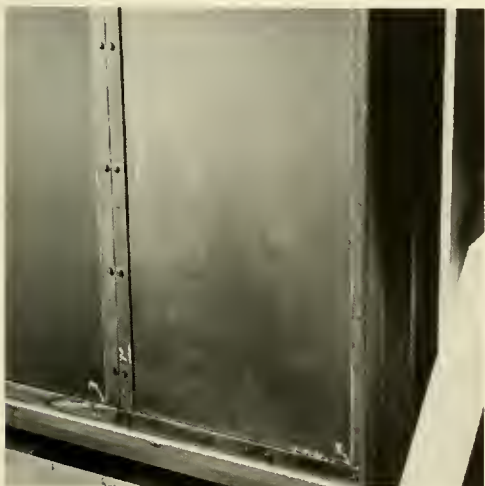
Figure 109
Photo No.: KSC-390C-2145.12
Dup. Neg. No.: L91-7661
LISAR No.: EL-1994-00505
Photo Credit: KSC
Photo Date: 3/21/90
Location: KSC SAEF II
Subject: Postflight Detail of Tray A7

Figure 109 (Postflight). This close-up photograph of the PMR-15 panel shows the geometric interference pattern that is visible when viewed from an oblique angle.

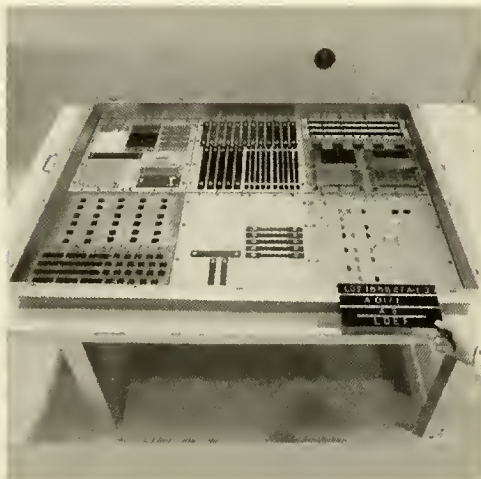
Figure 110 (Preflight). Six plates of passive components, provided by various organizations and designated plates I through VI, were mounted in the tray. Plate I, located in the upper right corner, consisted of a combination of solar cells with and without covers, solar cell modules, and solar arrays assembled on the baseplate. Plate II, located in the upper center section, had 27 composite samples (carbon fiber and glass fiber) mounted on the baseplate. Plate III, in the upper left corner, consisted mostly of metallized and thin polymeric specimens (such as Kapton, Mylar, Teflon, and white Tedlar films). Plate IV, located in the lower right corner, consisted of metals and coatings mounted in an aluminum baseplate and covered with a thin aluminum coverplate that partially masked the specimen. Plate V, in the lower center, contained thermal plastics and structural film configured into tensile and shear specimen. Plate VI, in the lower left, was populated with solar cells and associated components (covers, encapsulants, and adhesives).

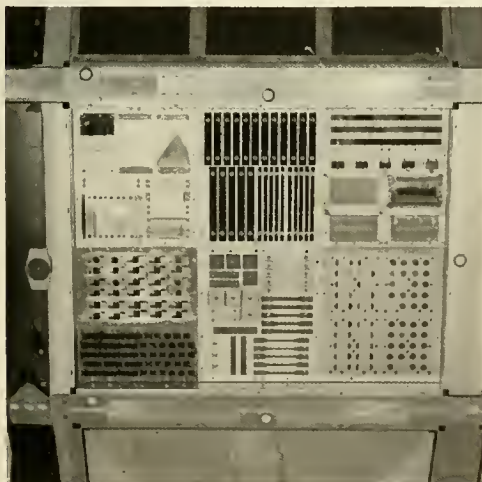
Figure 112
 Photo No.: KSC-390C-1031.12
 Dup. Neg. No.: L90-13422
 LISAR No.: EL-1994-00147
 Photo Credit: KSC
 Photo Date: 2/9/90
 Location: KSC SAEF II
 Subject: Postflight Survey of Tray A8

Figure 112 (Postflight). Most test specimens in the experiment appear to have survived intact, while the remaining specimens suffered varying degrees of deterioration. On Plate I in the upper right, three of the four solar arrays are missing. One solar array apparently was the one that was flying free near the LDEF just prior to retrieval and another was found in the Space Shuttle bay after the LDEF removal. On Plate III, in the upper left, thin films without protective coatings sustained significant damage or were destroyed.

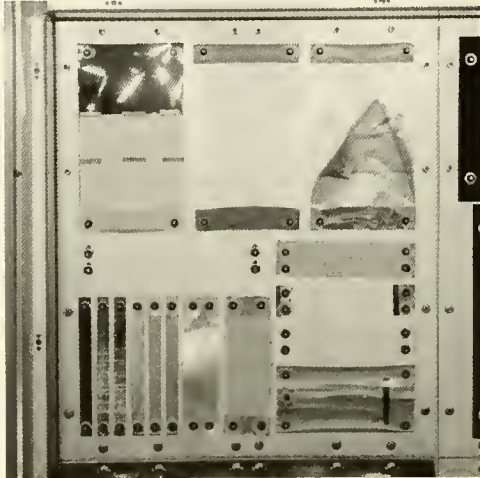
Figure 113 (Postflight). This close-up photograph of Plate 111 in the upper left one-sixth of the tray shows that the thin films without protective coatings sustained significant damage or were destroyed. The thin-film specimen, which is hanging by one end in the in-flight photograph, is missing. The metallized film apparently survived the mission with minimum damage.

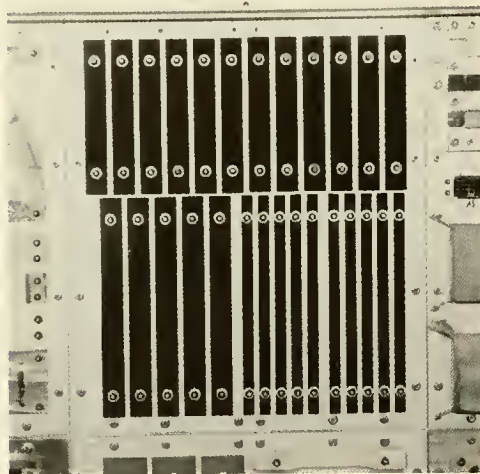
Figure 114 (Postflight). In this close-up photograph of Plate 11 in the upper center one-sixth of the tray, the composites appear to have no physical damage.

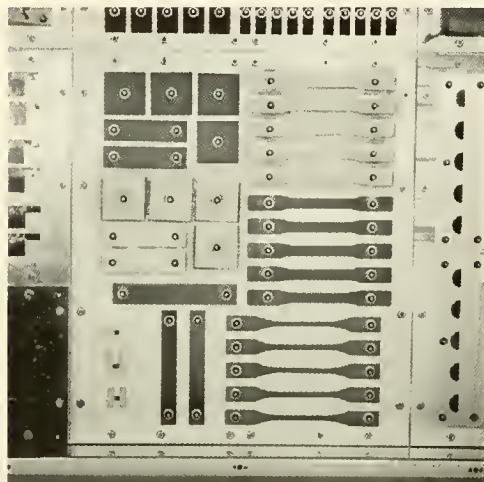
Figure 117 (Postflight). This close-up of Plate V in the lower center one-sixth of the tray shows that all specimens, including the tape holding down the small specimens in the lower left corner, have darkened significantly.

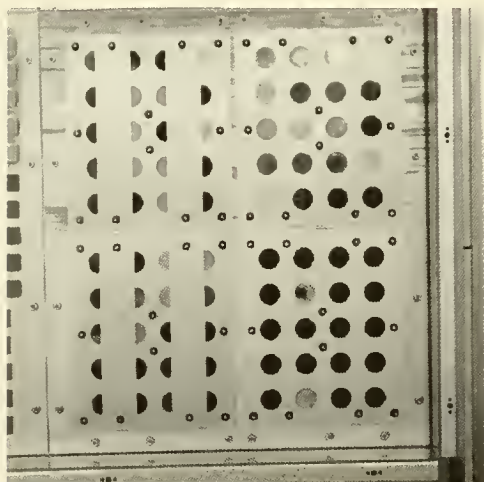
Figure 118 (Postflight). In this close-up of the lower right one-sixth of the tray, several of the coatings appear to have darkened and a unique pattern of light brown discoloration appears around the outer edges of the mounting plate and along the lower edge of the coverplates.
